Enviroparks Site Supervision

Revised Temporary Wildlife Protection Area - Completion of Mitigation Works

Date: October 2016

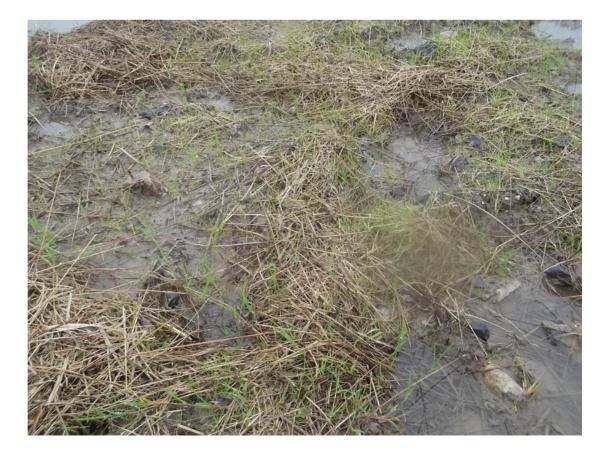
Plate 1: Grass seeded area germination (28.09.2016)

Grass seed had germinated during September (see Plate 1 below). Wild flower seed will germinate next spring.

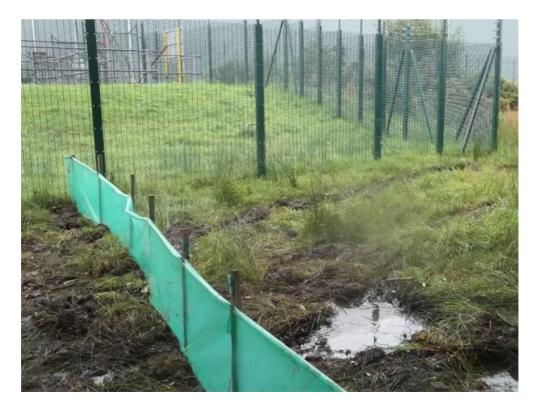
Plate 2: Reptile fence (north eastern end)

In the north east of the site a strip has been cut through the willow scrub to enable the fence to be erected through to the Dwr Cymru Site.

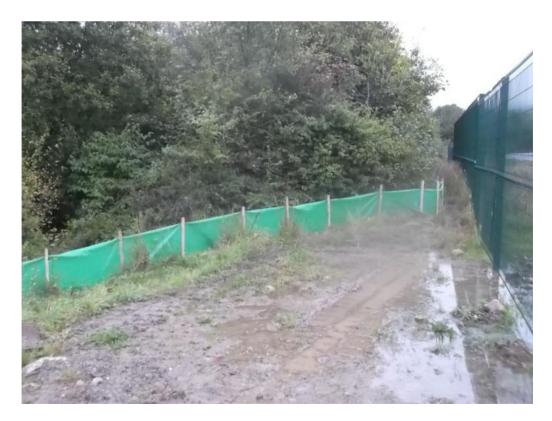
Plate 6: New section of fence (south western end)

The south west section of the existing reptile fence was repaired and a new section erected to connect the fence through to the stream next to the concrete culvert. Bramble growth was cut back along this section to protect the fence.

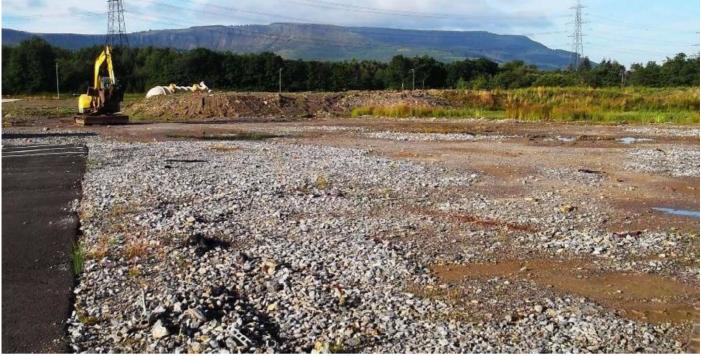
Before

It quickly became apparent after four trial holes, that the area for subsoil breaking, was in fact stone laid on a terram sheeting, to a depth of 300-400mm. The drainage was similar to natural ground conditions, which has a high water table and standing water in hollows, and a very clay soil, with regular round boulders in. This is known from pervious fencing work on site, with included trenching for the earlier reptile fence.

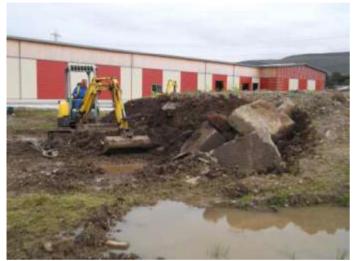
Soil being taken from bund

A small amount only of ground breaking was undertaken. Subsoil from the bund was spread to a depth of circa 100mm, left quite rough, in part to the very claggy clay soil, in part due to boulders in the mix and in part due to the purpose of creating reptile habitat.

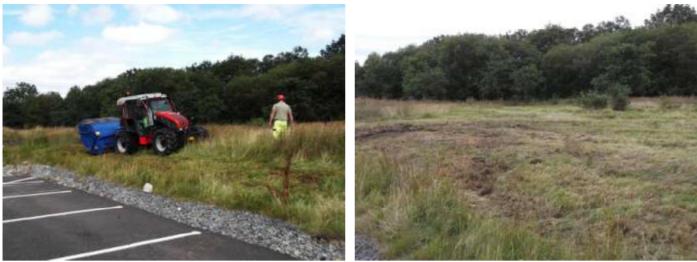
Flail mower seed collection

This went smoothly, with grass seed collected from the allocated area, by means of a specialist flail mower and collector. Because of the delays in the preparation of the receptor site the mowing were stacked at different locations around the receptor site and later spread by hand, rather than the planned small muckspreader. This made little difference to the work schedule.

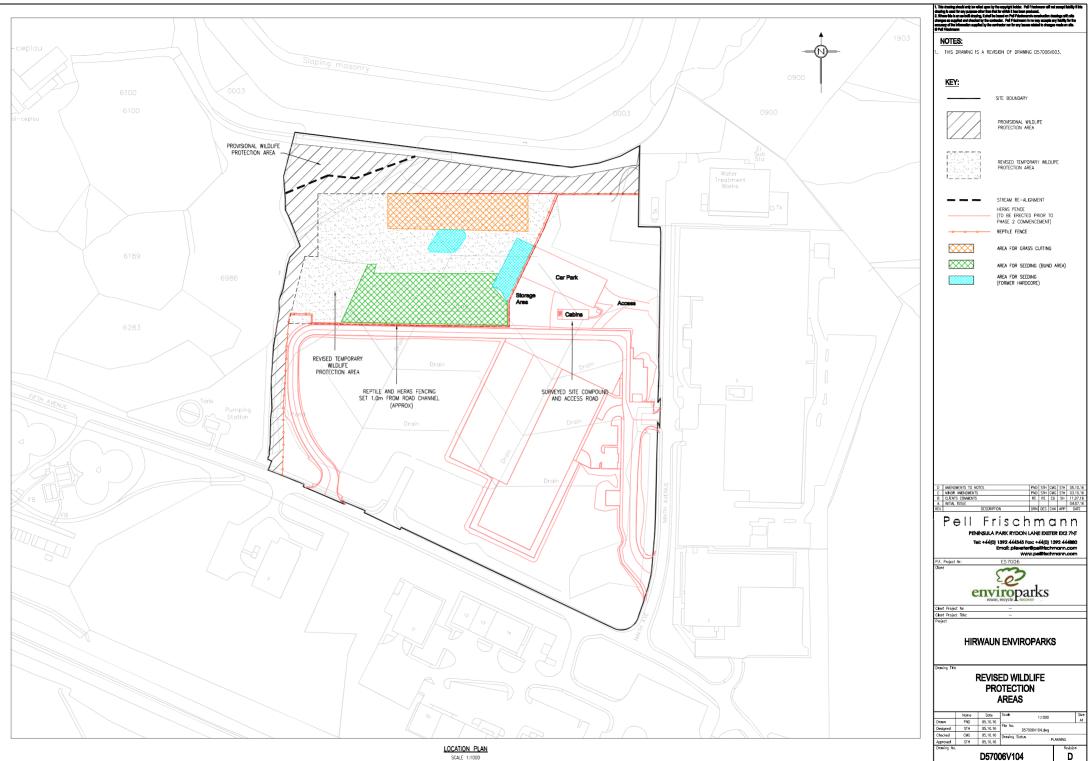
Appendix B – Revised Temporary Wildlife Protection Area

Grass/wildflower seed was collected from the northern end of the site using a flail mower and specialist collector. The area mown is shown as '*Area for Grass Cutting*' on drawing D57006V104 C (attached in Appendix B).

The new reptile fence was erected as shown on the Temporary Wildlife Protection Area Plan D57006V104 C (attached in Appendix B).
