HIRWAUN 17 ACRE SITE

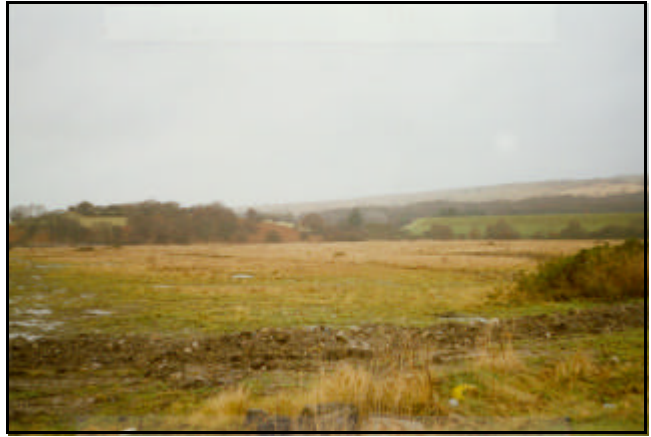
Site conditions prior to re-grading

The agreed proposal for the A.P. Works was to remove the unsuitable overburden, with its placement on the extremities of the site for landscaping purposes, and the implementation of a re-grading operation using the underlying boulder clay to give acceptable cross grades to the site. The low lying areas adjacent to the stream were also raised to eliminate the risk of flooding from this source.

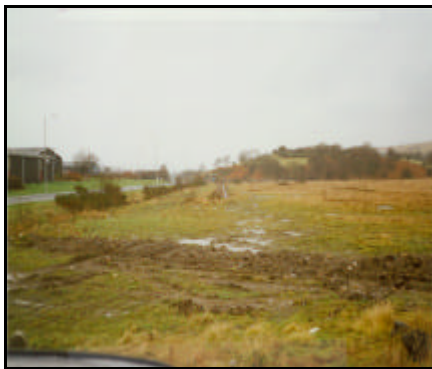
Site Conditions prior to re-grading

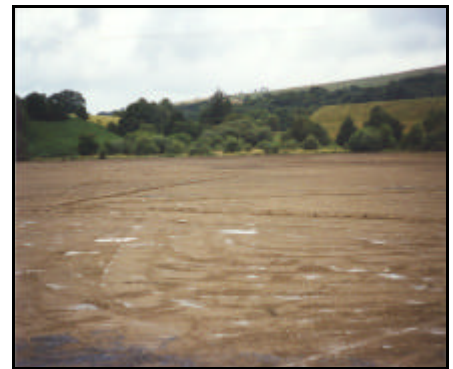
Completion of re-grading works were hampered during construction due to the weather affected nature of the boulder clay contained in a sandy matrix

Initial re-grading

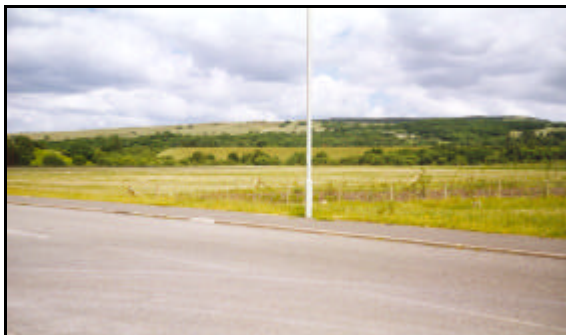
Final Site Layout

Following re-grading works, which were suspended for some two months until weather conditions proved suitable, the site was drained with temporary open channels and ditches prior to seeding of the resulting plateau, with landscaping to the extremities, as shown in the photographs below.

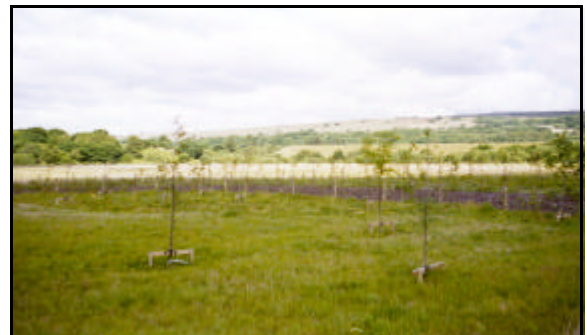
Final Site Layout
